Achieving Energy Star® and Beyond

Cielo Azul Vineyard Residence | Chino Valley, AZ

An Overview of a High-performance Home in a Mixed-Dry Climate

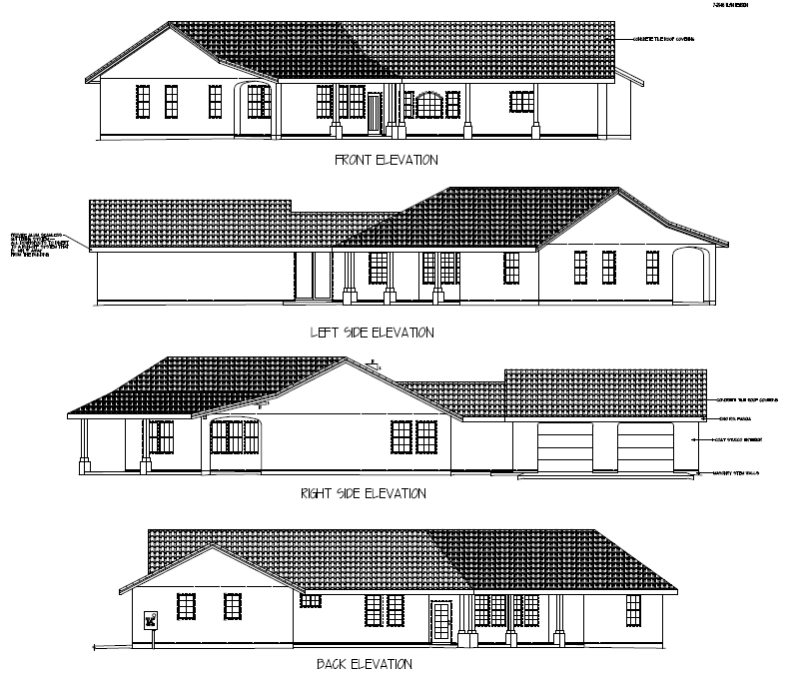
In 2017, Prescott Green Builders completed a 2200 ft² residence for the owners of Cielo Azul Vineyard in Chino Valley, Arizona (about 20 miles north of Prescott). The residence was designed and constructed to meet high standards for energy efficiency and durability. To verify these high standards, the construction process was monitored and on completion was certified as an EPA Energy Star® home by an independent RESNET home-energy rater. The home achieved a 49 on the Home Energy Rating System (HERS) index, where 0 represents parity between energy use and energy generation, and 100 represents the “standard” U.S. new home (see graphic).
